PHASE I GEOENVIRONMENTAL SITE ASSESSMENT

Land West of Magna Park
Cross in Hand
Rugby

Nurton Developments (Lutterworth) Ltd.

C1602/EAJ/jt/20230199
November 2023

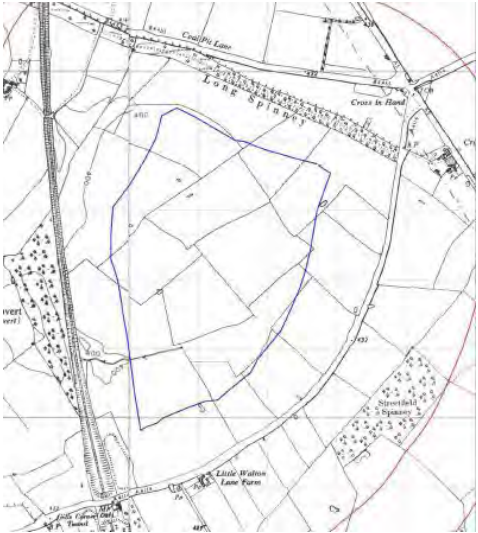
MAP EDITION	HISTORICAL LAND USE	HISTORICAL MAP EXCERPT
<p>1954 1:10,560</p>	<p>A drain is recorded in the southwestern sector of the site with the direction of flow going west towards the railway cutting.</p> <p>No other significant changes recorded.</p>

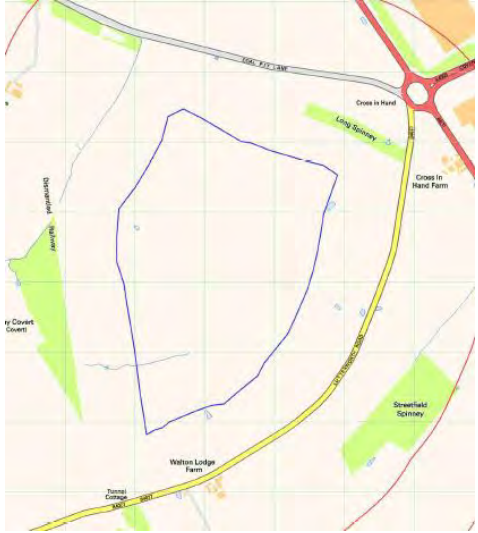
<p>2001 1:10,000</p>	<p>The railway has been decommissioned and infilled. The mound in the southwest corner is likely to have been used for infilling, though this cannot be confirmed.</p> <p>Some of the site ponds appear to have been infilled.</p> <p>No other significant changes recorded.</p>

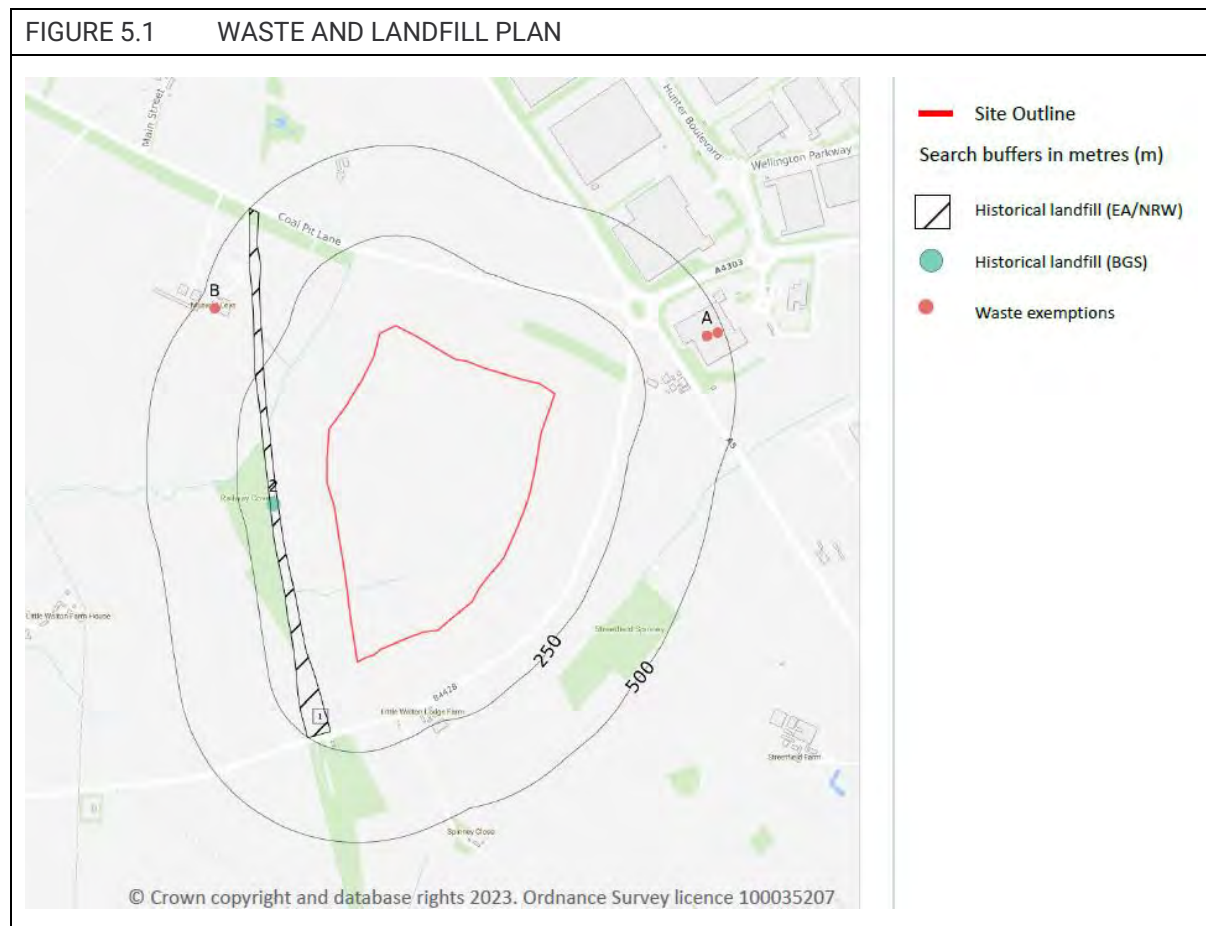
Environment Agency records indicate this cutting was infilled between c. 1970 and 1972.

The location of the landfill is presented in Figure 5.1 below.
