Nurton Developments Ltd

**Land West of Magna Park, Cross in Hand,
Rugby**

TREE SURVEY TO BS 5837:2012

our ref: 2393 / TGW / TR001
date: 18/01/2024
prepared by: TGW
checked by: [director]

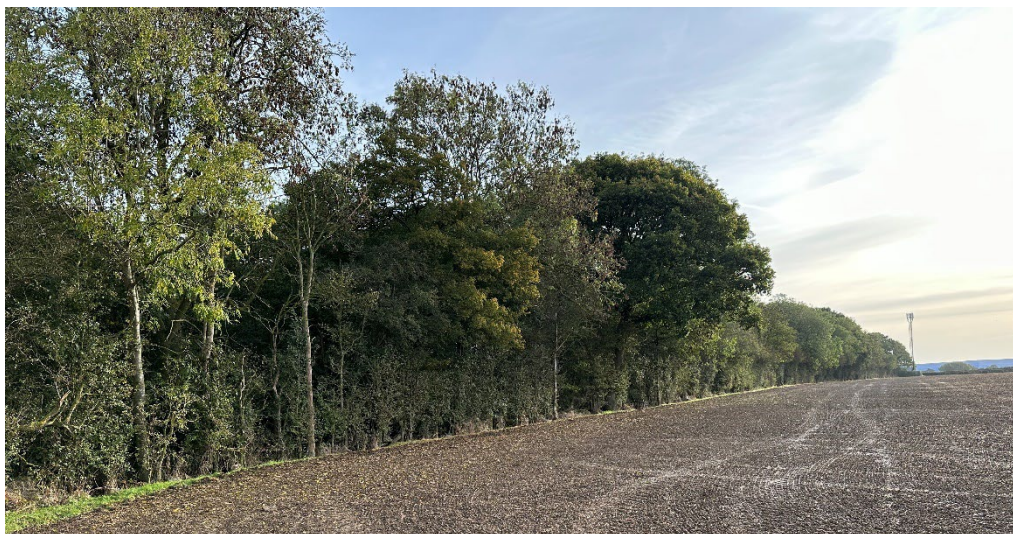
Photo of W01, Long Spinney, showing how the combined effect of the individual trees results in a Category A High quality.

- 3.2 The woodlands to the boundary of the site are of different ages, species and condition. However, the combined effects of the individual trees means that collectively these woodlands have been given a Category A, High Quality status due to their prominence in the landscape.

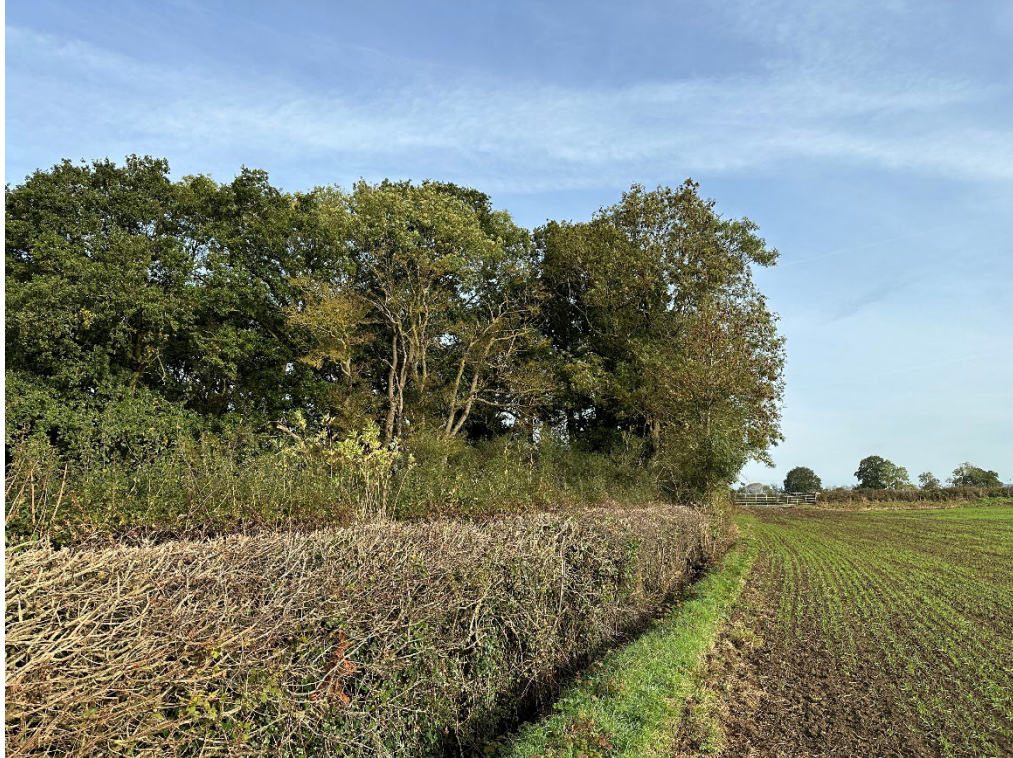
Photo of W02, which is located just outside of the northern boundary of the Site.

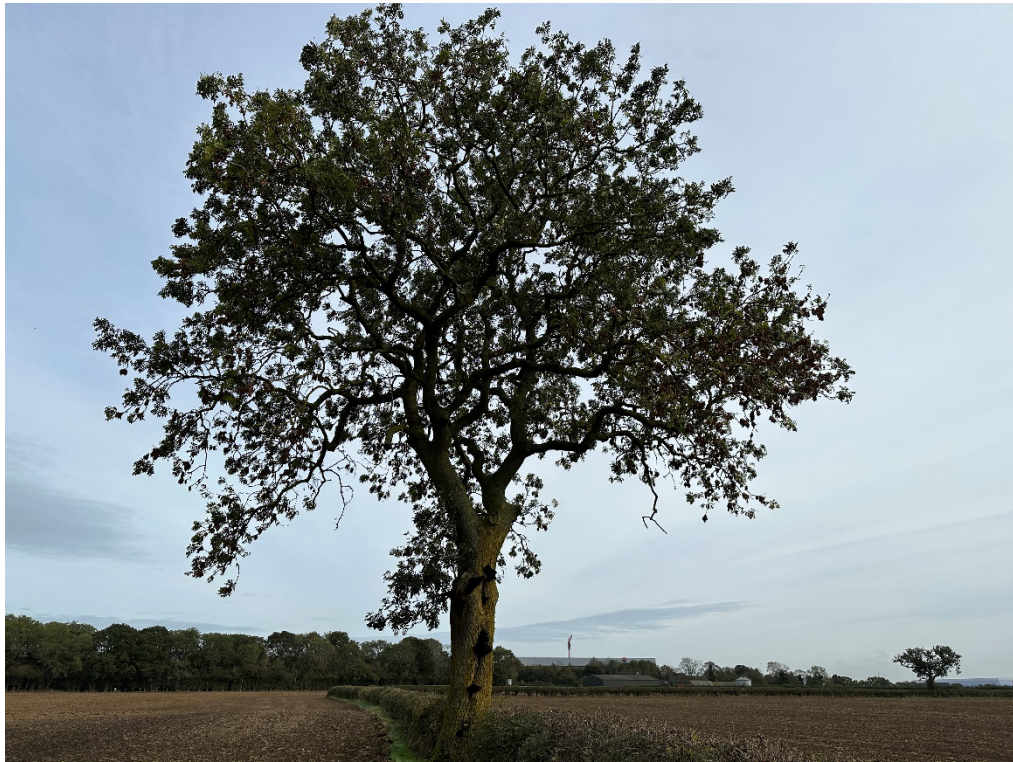
- 3.3 By contrast the majority of the trees within the site and within the hedgerows are mainly Ash trees, most of which have reached maturity. Where these are still vigorous specimens they have been given a B category of moderate quality. However, where they have started to decline they have been listed as C category Low quality and where there are signs of severe decay and fungal rot they have been given a category U, unsuitable for retention.

Photo typical of many of the mature ash trees on site showing extensive fruiting bodies of Shaggy polypore (*Inonotus hispidus*).

8.1 As identified within the survey a number of Ash trees are being colonised by Shaggy polypore (*Inonotus hispidus*) a white and soft rot parasitic fungi that rapidly affects the upper portions of the trunk, main ascending stems and principal branches, leading to branch snap or break out and the trees eventual demise.

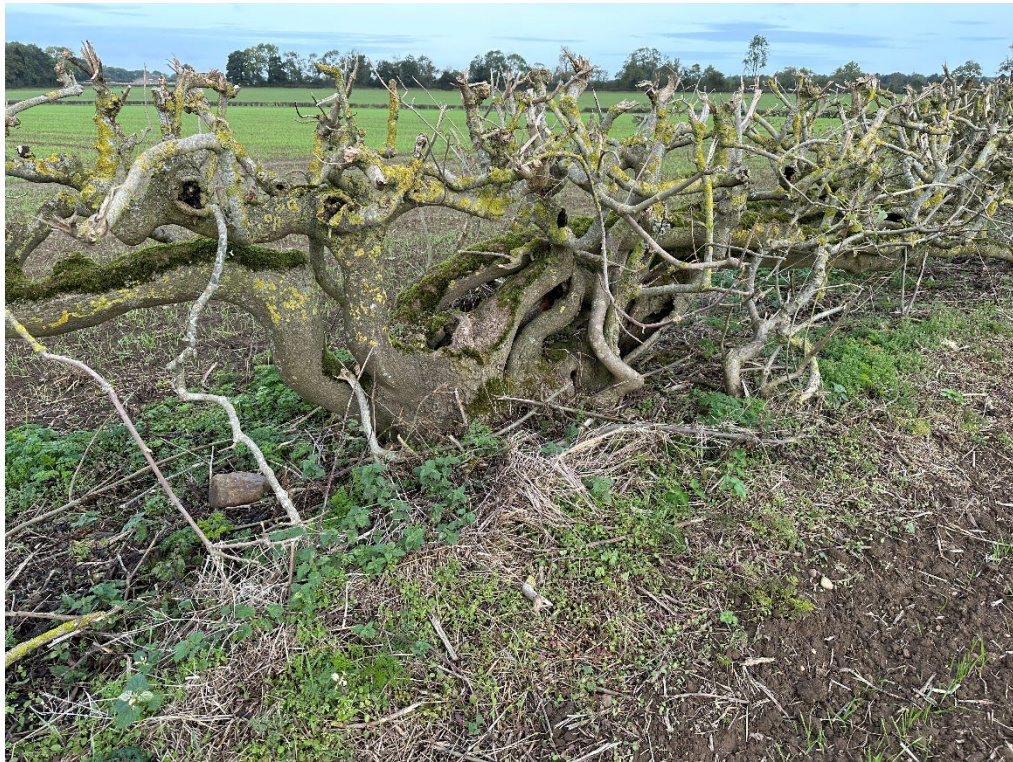
- 3.4 The hedges surveyed within the survey area are also of mixed ages, but there are several sections of hedgerows which have the characteristics of being very old. Some of these older hedgerows do show signs of having been laid but in recent years they have all been maintained by mechanical means. The result of this is that some of the older hedgerows are now quite gappy at the base.

Photo of a old hedgerow showing how at one stage that it had been laid but now is maintained by mechanical means resulting in a gappy base.
