Client: Rugby Borough Council
Title: Addendum to Local Plan Site Allocation Heritage Assessment

# Heritage assessment of local plan site allocations for **Rubgy Borough Council**

## Land north of Houlton

Site reference: 130

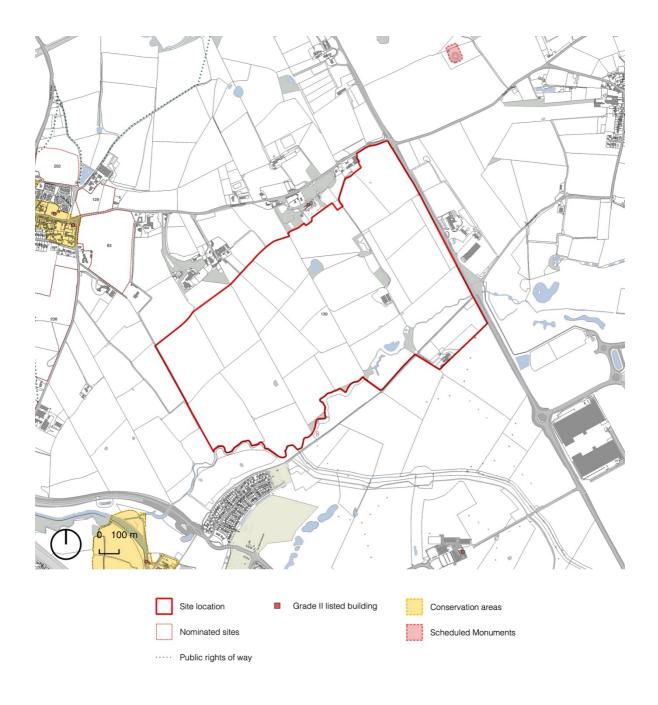
Site location and designated heritage assets

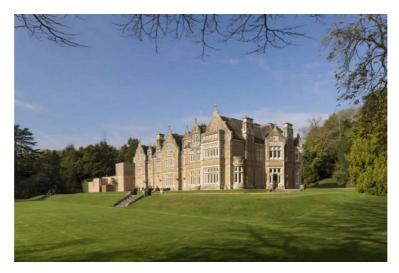
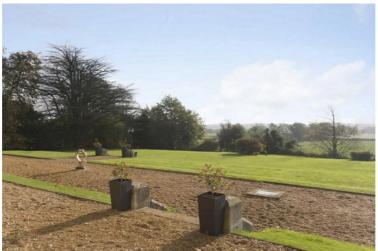
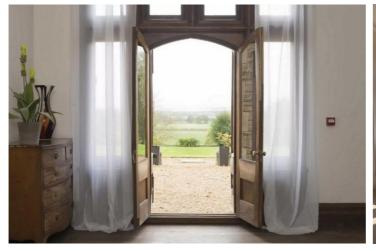
Dunsmore House and its landscape parkland garden as illustrated in 1902 Ordnance Survey mapping, 1950s RAF aerial photography, and modern imagery (with site boundary annotated).

The house's ornamental garden and parkland are components of its original design, and, in turn, are important elements of its significance (via setting). The house's close setting includes a woodland west of the house containing meandering paths, and a south-east facing series of garden terraces extending from the long, ornate elevation. The design of the terracing, gardens, and woodland indicates this area was specifically designed to embrace and frame the dramatic, panoramic views across the rural landscape to the southeast, gifted by the house's elevated position. This view is also experienced from within the house through large windows and from key living- and reception rooms. In our judgement these factors strongly suggest the creation, and framing of the view was a consciously designed element of Ward's original scheme – a "set piece" experience, and an important element of the listed building's significance, accordingly.

In the foreground of the view is an area remnant of a designed parkland for Dunsmore House, featuring a copse, ornamental pond (possibly adapted from an earlier agricultural feature), a clearly defined boundary, and scattering of surviving field trees. Such landscapes were typical of such developments: adopting the aesthetics of the English landscape tradition, albeit at a smaller scale, to further bolster the impression of wealth and status given by the house. While there has been some erosion of its features, primarily through a return to agricultural use, the parkland remains a tangible element of a designed landscape setting to the listed building. The local Historic Environment Record denotes this landscape (MWA12644); however, we note the HER's mapping is in error, by including only the northern half of the parkland and using boundaries not aligned to the historic mapping nor modern landscape evidence. Neighbouring the parkland and glimpsed from the set-piece view are a collection of rural fields. These provide further bucolic framing to the parkland area, and further amenity to the view.

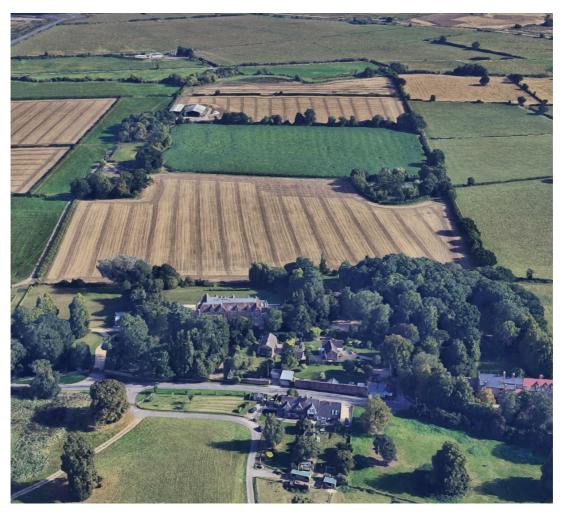
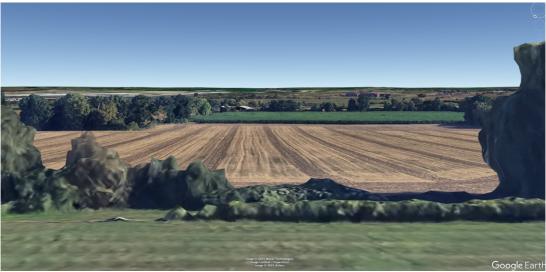
2016 photographs from Dunsmore House sales particulars (source: The Hinkley Times) illustrating its accomplished southeast elevation, the garden terrace with (partially visible) the panoramic view across neighbouring parkland and rural lands, and the influence of that view within southeast facing internal rooms and reception spaces.

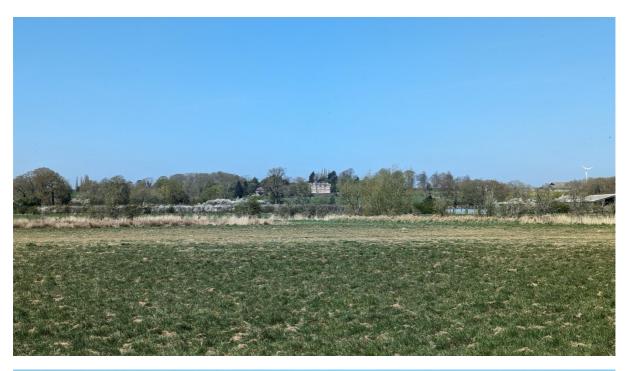
Google Earth imagery, representing the character and extent of the key, "set piece" view (security restrictions prevented access to the premises). The parkland and neighbouring fields are visible to the foreground (all within the site), the former RAF airfield to the middle ground, and (not rendered) large sheds and wind turbines draw the eye in the once rural view to the background.

Beyond the parkland and fields, the views encapsulate a wider landscape of greater diversity in character. Originally this would have been a long, rolling rural vista, and while rural characteristics

remain significant there has been intrusion from large modern infrastructure and industry. The large sheds adjacent the A5, and wind turbines to the backdrop are prominent. There is, therefore, something of a contrast between the strong, positive contributions of the fore- and middle ground of the view, and the less welcome aspects (for heritage) to their backdrop.

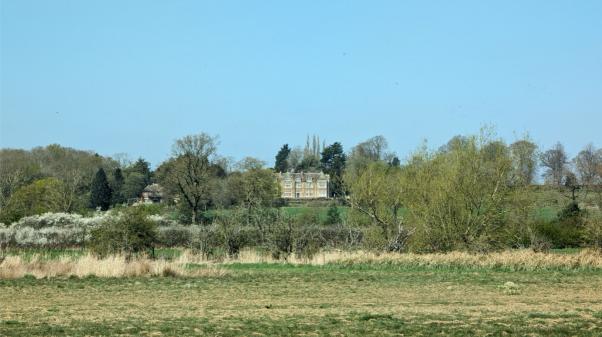
View of Dunsmore House (grade II listed) across the site from the public right of way

A reciprocal view of the Dunsmore House is afforded from the publicly accessible track at the site's southern boundary. While the house is perhaps too distant to form a landmark, it is still an eye catching and intriguing feature of architectural interest perched atop the ridge.

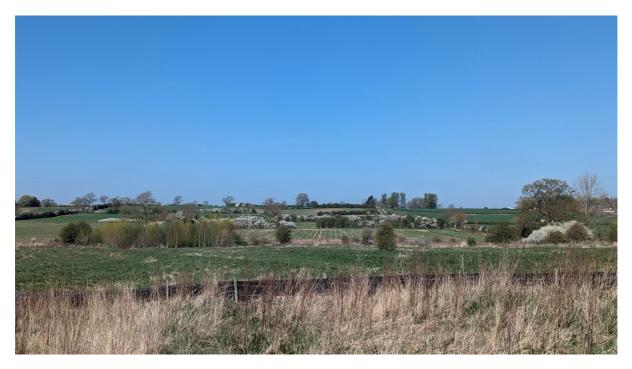
General character of the site, as seen from the public right of way to the south looking north

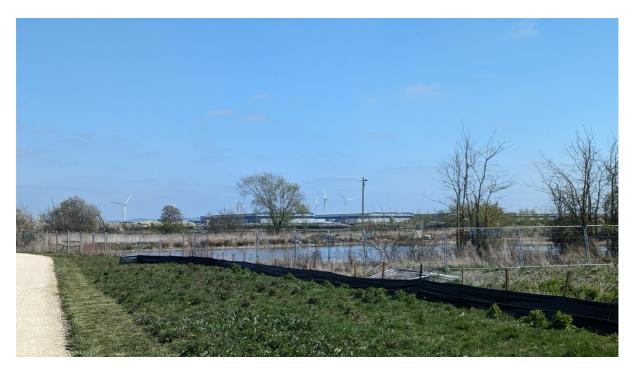
Growing influence of large commercial sheds and renewable energy within the site's surroundings
