FLOODING RISK TO WILLOUGHBY

A.W.Ogle CEng MIMechE

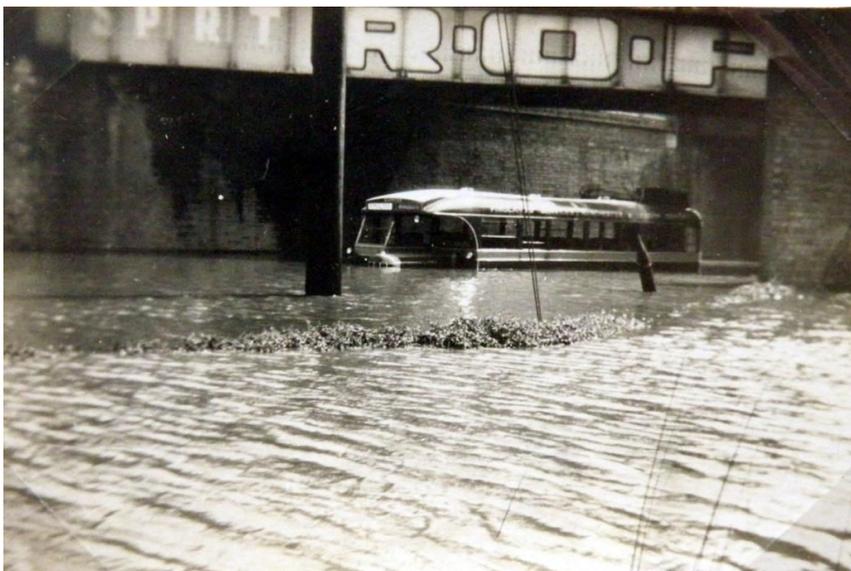
Photograph 1. Flooding at Willoughby Station 1932

The construction of The Great Central Railway in 1898 caused interruption to the natural surface run off the fields to the east of the rail line, giving rise to accumulation of floodwater beneath the bridge at the old station. To alleviate this a drain was excavated, in 1937, to take floodwater from the A45 via the fields of White House Farm and College Farm, to flow into the Willoughby Brook opposite the Village Hall.

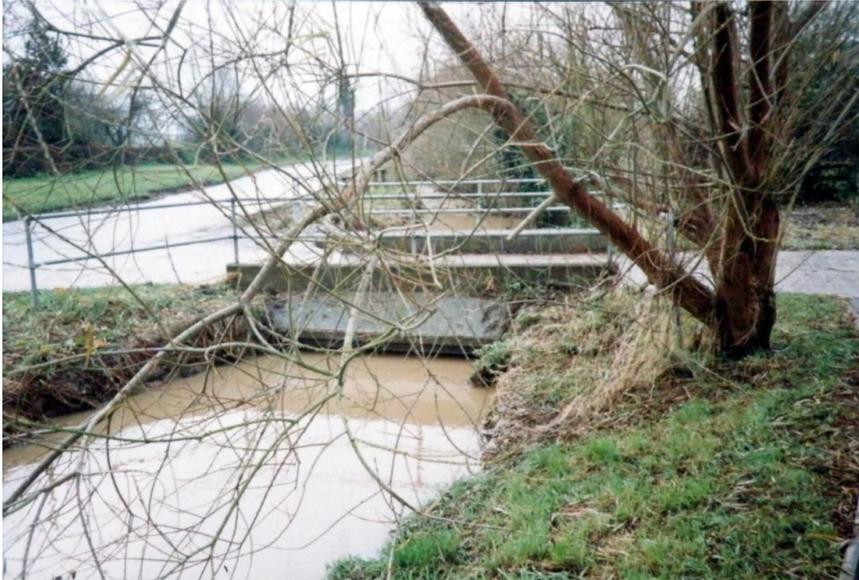
Photograph 2. Water level rising to parapet of occupation bridge on Moor Lane

The most significantly affected point in the village during any flooding episode is the junction of Main Street and Lower Street, where the brook passes under Main Street via two culverts. As the water level downstream rises the brook backs up to top its bank. As seen in Photograph 2. the water level in the brook rises until the occupation bridge at the end of the footpath along Moor Lane is submerged.

The water level rises to the top of the parapet because the increased head only gives rise to a relatively small increase in flow under the bridge. The increase in level is reflected to the two culverts at the end of Lower street, causing further inhibition of the flow and increased water level. During flood build-up the water flowing down the brook tops its bank at the bridge by the village hall (Photograph 3) and very quickly floods the road and gives rise to build up of floodwater at the Main Street/Lower Street junction. As the water builds up, houses in Lower Street are at risk of flooding as the increasing depth of water extends along the street towards Brooks Close.

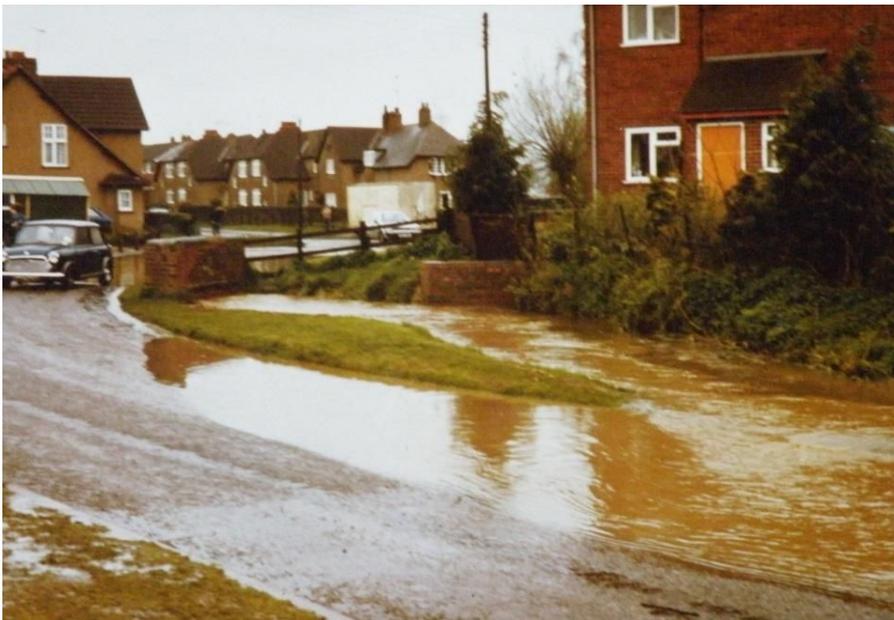
Photograph 3. Brook topping bank at Village Hall Bridge

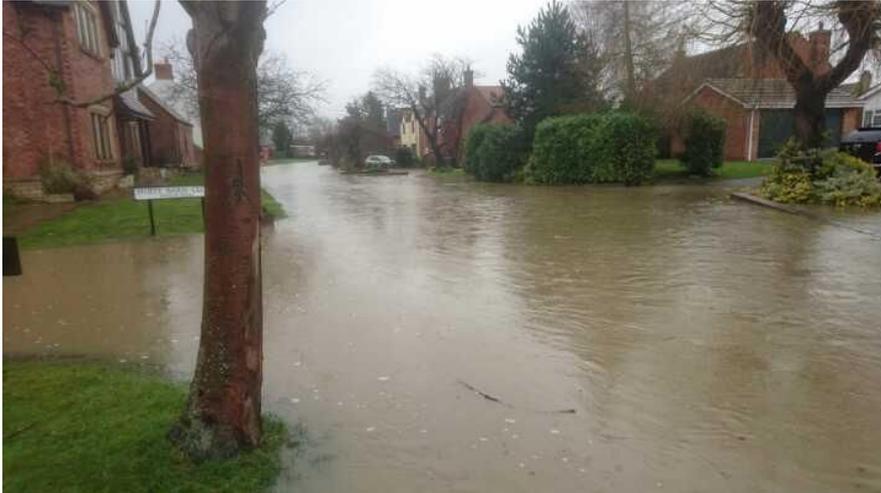
Photograph 4. Flooding at White Barn Close junction with Main Street on 6th October 2016.

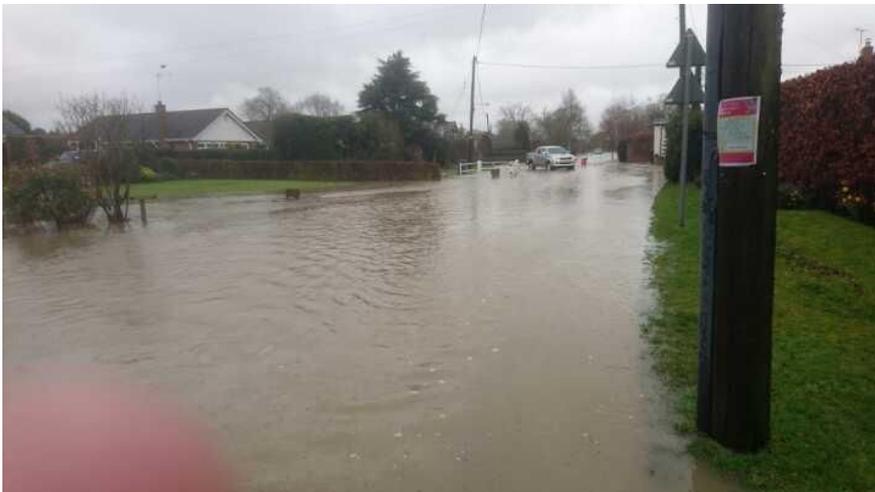
Photograph 5. Flooding at lower section of Main Street on 6th October 2016

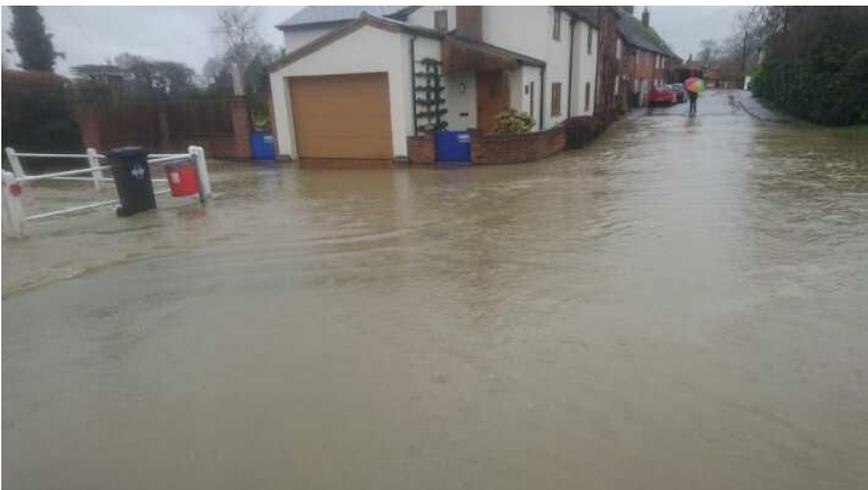
Photograph 6. Flooding - Lower Street 6th on October 2016

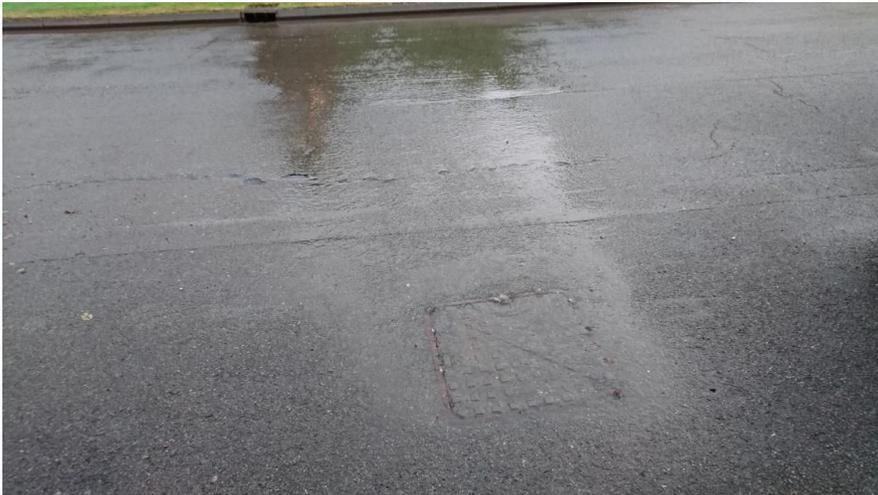
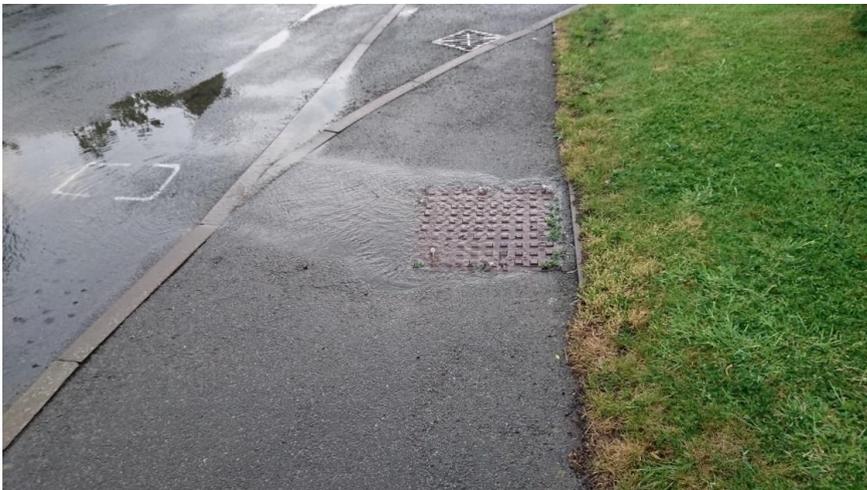
Photograph 7.

Flash Flooding occurs when rainfall of high intensity does not soak into the land or enter water courses and storm drains cannot take the full quantity of water. This can be because the land is saturated or parched. When sewers or road drains are overloaded the excess flood water bypasses them or, in some cases, re-emerges from such drains. See Photographs 7 and 8.

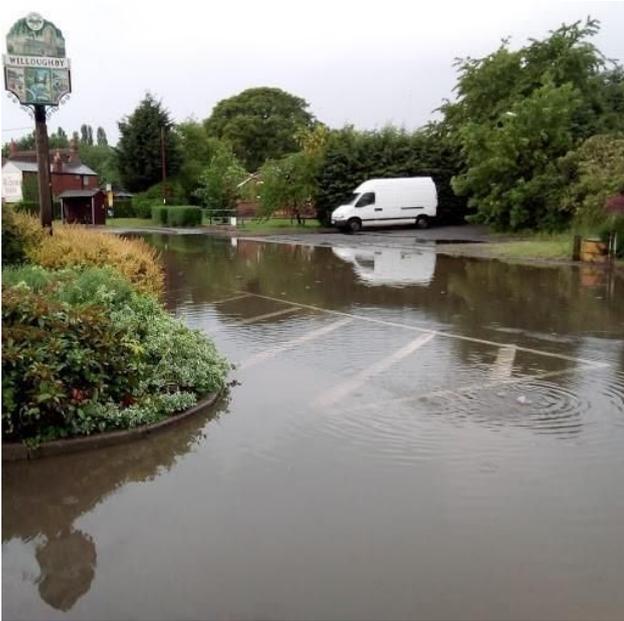
Photograph 9.

This was the cause of flooding at critical points in Willoughby on Sunday, 27th May 2018. Over 20 minutes, 25mm of rain fell over the village. This resulted in flooding to several garages and minor water ingress into properties. The roadway was flooded to a depth of 300-350mm, as shown in Photograph 9, and sewers and road drains were saturated. The Willoughby Brook and Great Central Station Drain were low in level. (Photograph 10). It took some 30 minutes for the flooding to abate and it was only after this time that the brook water level started to rise as runoff upstream of Willoughby began to fill the brook.

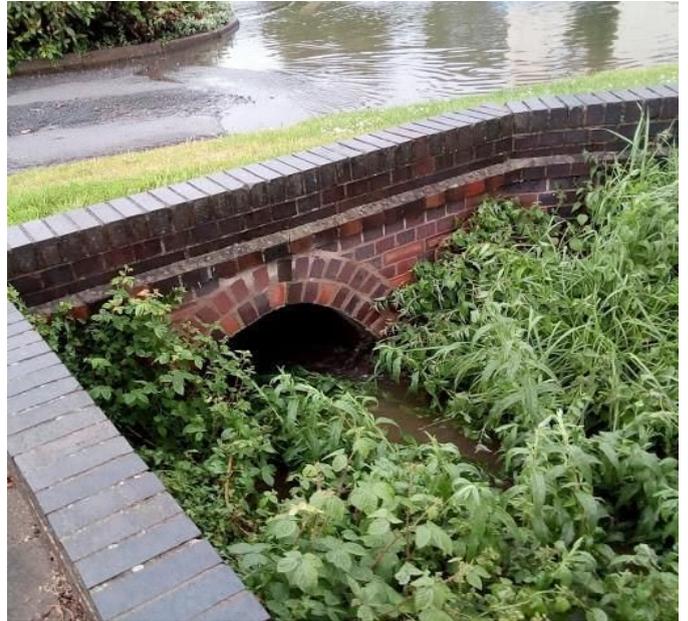
Photograph 10. shows the flooding event in May 2018. Note that the road flooded whilst the drain from the A45 at the old railway station is not at a high level.

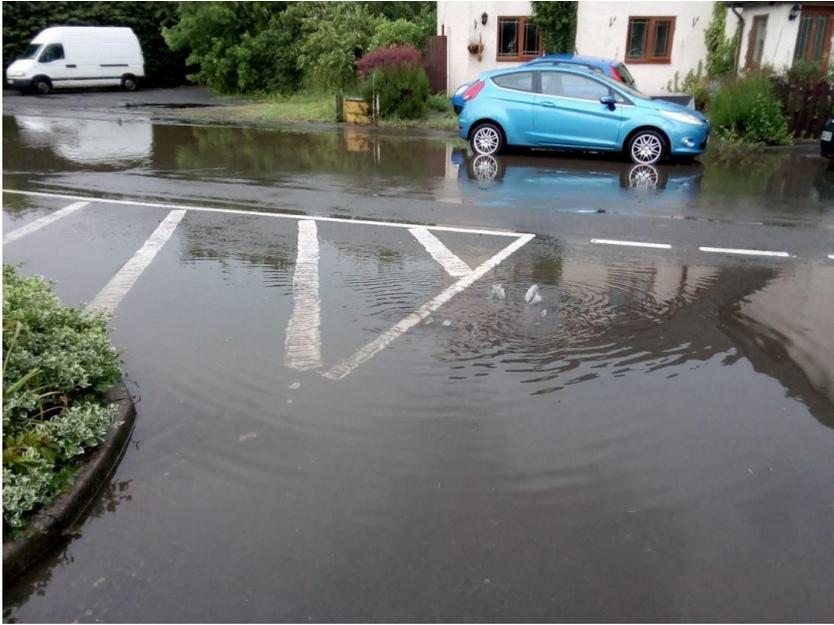
Photograph 11. below shows excess water being ejected from a main sewer man access cover in the road by the parish car park. Sewer Flooding occurs when the sewer network cannot cope with the volume of water entering it. To minimise this, it is essential that sewers are adequately sized and maintained. Figure 1 shows the sewer configuration for Willoughby. It is noted that the entire underground system is based upon 150mm piping, which is inadequate to deal with excess water during heavy rainfall. Maximum loading of the sewage system is an important criterion when considering new development. It is also important that surface water, that can be drained elsewhere, should not be allowed into the sewer network, to reduce the loading on both the sewers and the sewage treatment plant. The possibility of increased bore size should be considered for parts of the network.

Photograph 11. Flooding on 27th May 2018 showing sewer refluxing.

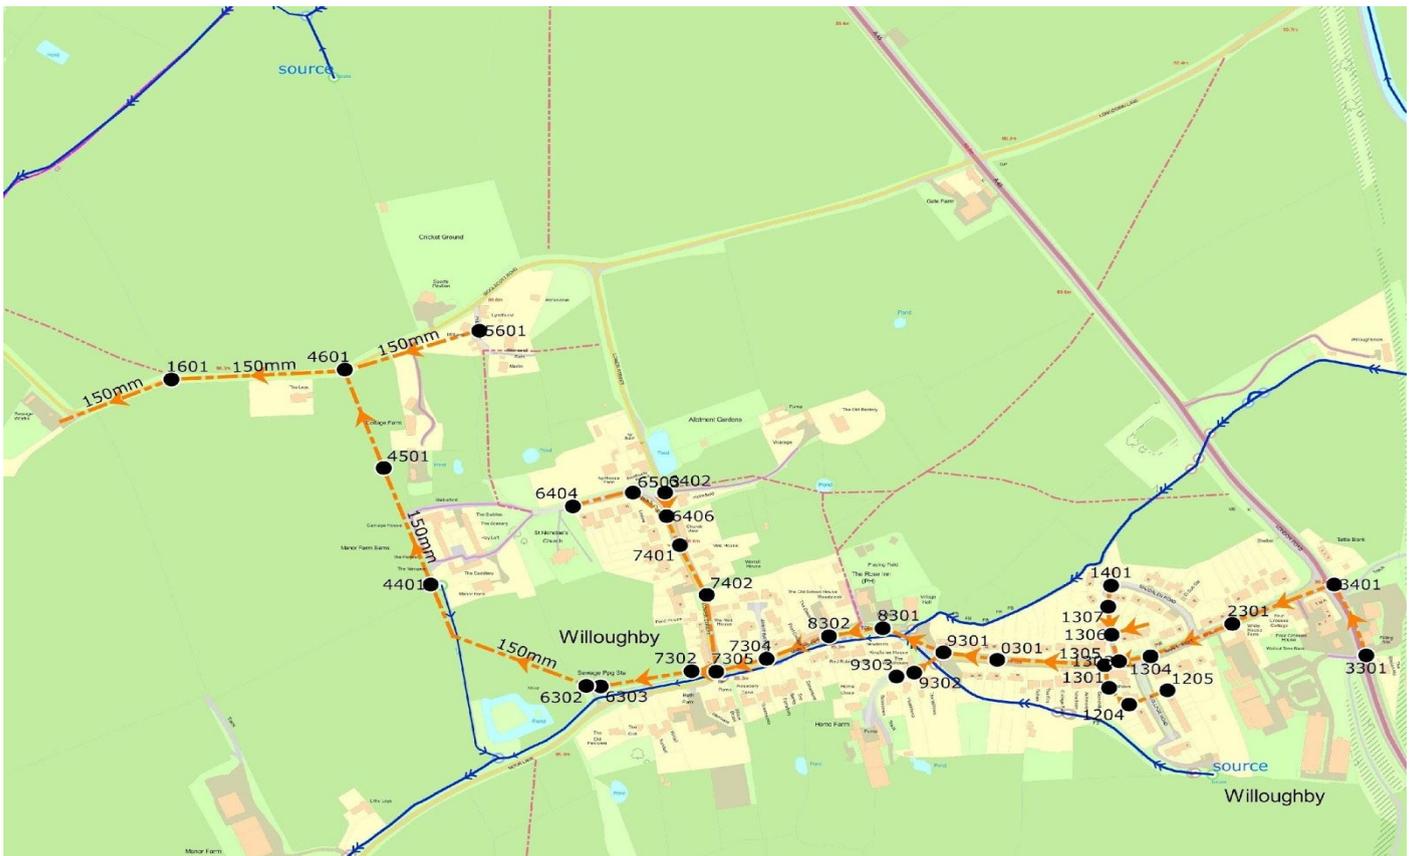
Figure 1. Plan of Willoughby Sewer System

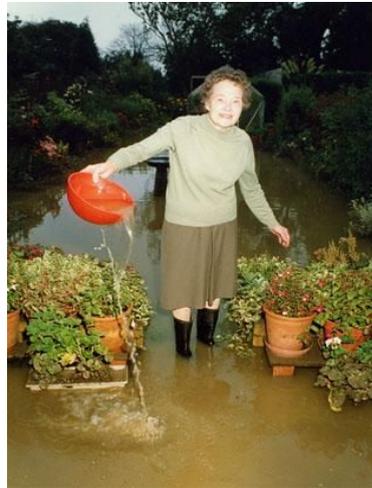
Photograph 12.

Flooded garden at Treetops, 56 Main Street in September 1992

In September 1992, when there was flooding in Willoughby, the level of flooding was greater than the regular pattern of flooding in the village. The Willoughby Brook substantially contributed to the flooding and water overflowed the watercourse flooding several houses to the north of Main Street including numbers 66 and 68. On two nights of the same week, water entered number 66 during the night, flowing through the property from rear to front, with water to calf level i.e. approx. 250mm deep. Numbers 56 and 58 Main Street were also affected. The A45 crossroads at Gate Farm was substantially flooded during this event.

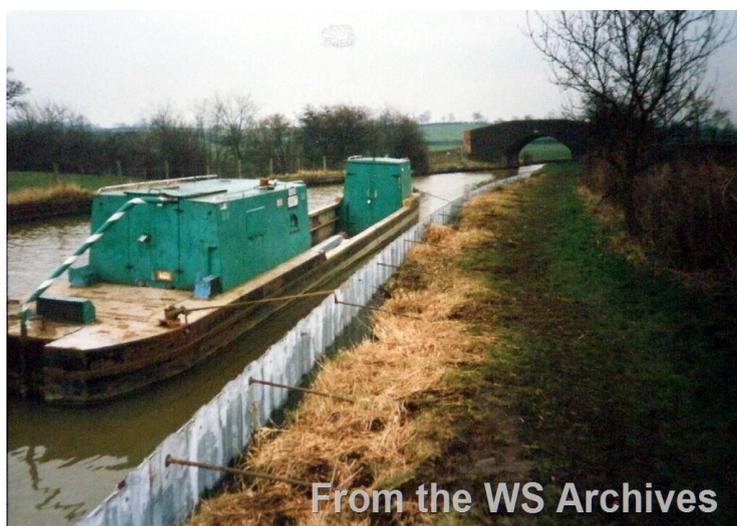
Photograph 13.

Raising the bank of the canal to prevent overtopping in 1998

It was widely recognised that the magnitude of 1992 floods and several earlier incidences in which substantial quantities of flood water flowed down Willoughby Brook were due to canal overtopping. Overtopping occurred along the section of canal above the culvert through which the Willoughby Brook passes. (Photographs 13. and 14.).

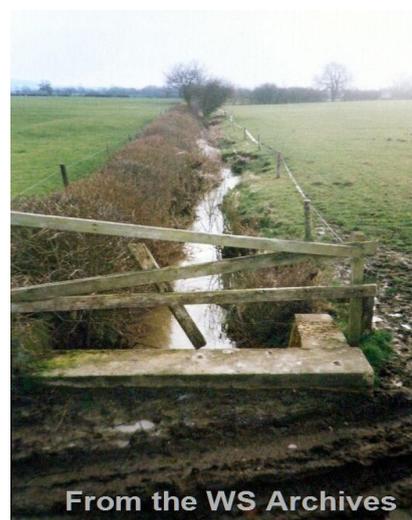
Photograph 14.

The canal bank above the brook in 1998 (Note the waterlogging to the right of the parapet)

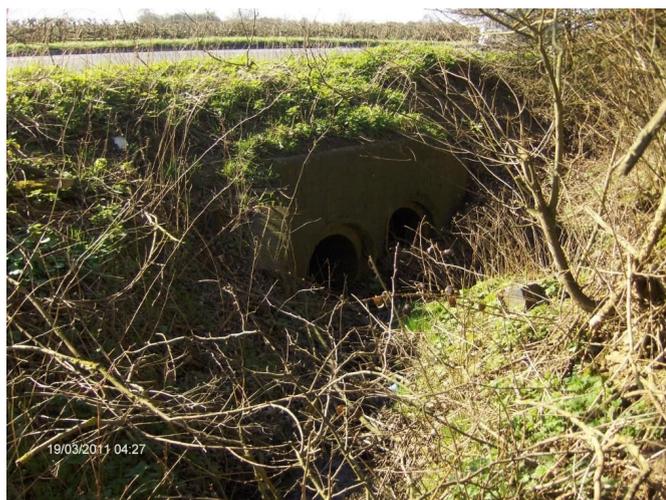
Photograph 15.

Partly silted culverts under A45

To minimise the quantities of canal water adding to flooding in Willoughby, the culverts under the A45, which are under the control of Northamptonshire Highways, need to be kept clear and the possibility of increased bore should be addressed.

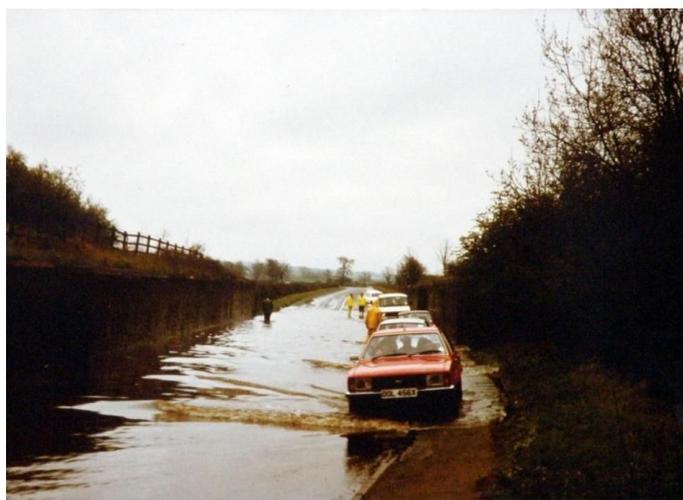
Photograph 16.

Flood water crossing A45 at site of Old Station Bridge

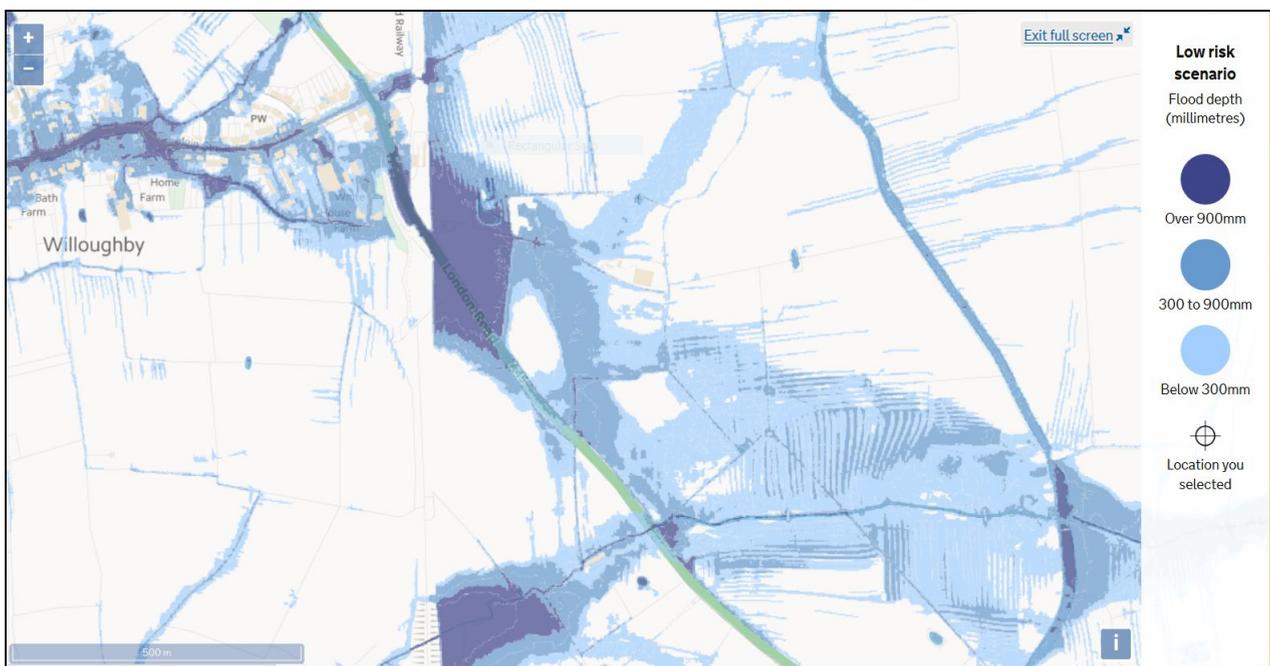
The "Flood Risk from Surface Water" map shows water entering the village from the east by several routes. The significance of The Great Central Railway embankment in holding up water is clearly shown.

Figure 3. Flood Risk from Surface Water

The Environment Agency Flood Maps are shown in Figures 3. and 4. Figure 3. is described as 'Flood Risk from Surface Water' and Figure 4. as 'Flood Risk from Rivers and Sea'.

Water supply to maintain the Oxford Canal, when it was built as a single level contour canal (i.e. without locks) was intended to rely on water from streams and springs. It can be seen from the surface water map, (Figure 3.) that where the cut crossed land which contained ridge and furrow these created artificial swales (ditches), allowing local surface water to be more readily fed into the canal. At MR:-SP535666 the stream which originates at Braunston Cleeves and flows to the north of housing in Braunston enters the canal. The accumulation of water shown to the east of the point of entry to the canal on both maps can only occur if there is a significant rise in the water level in the canal itself.

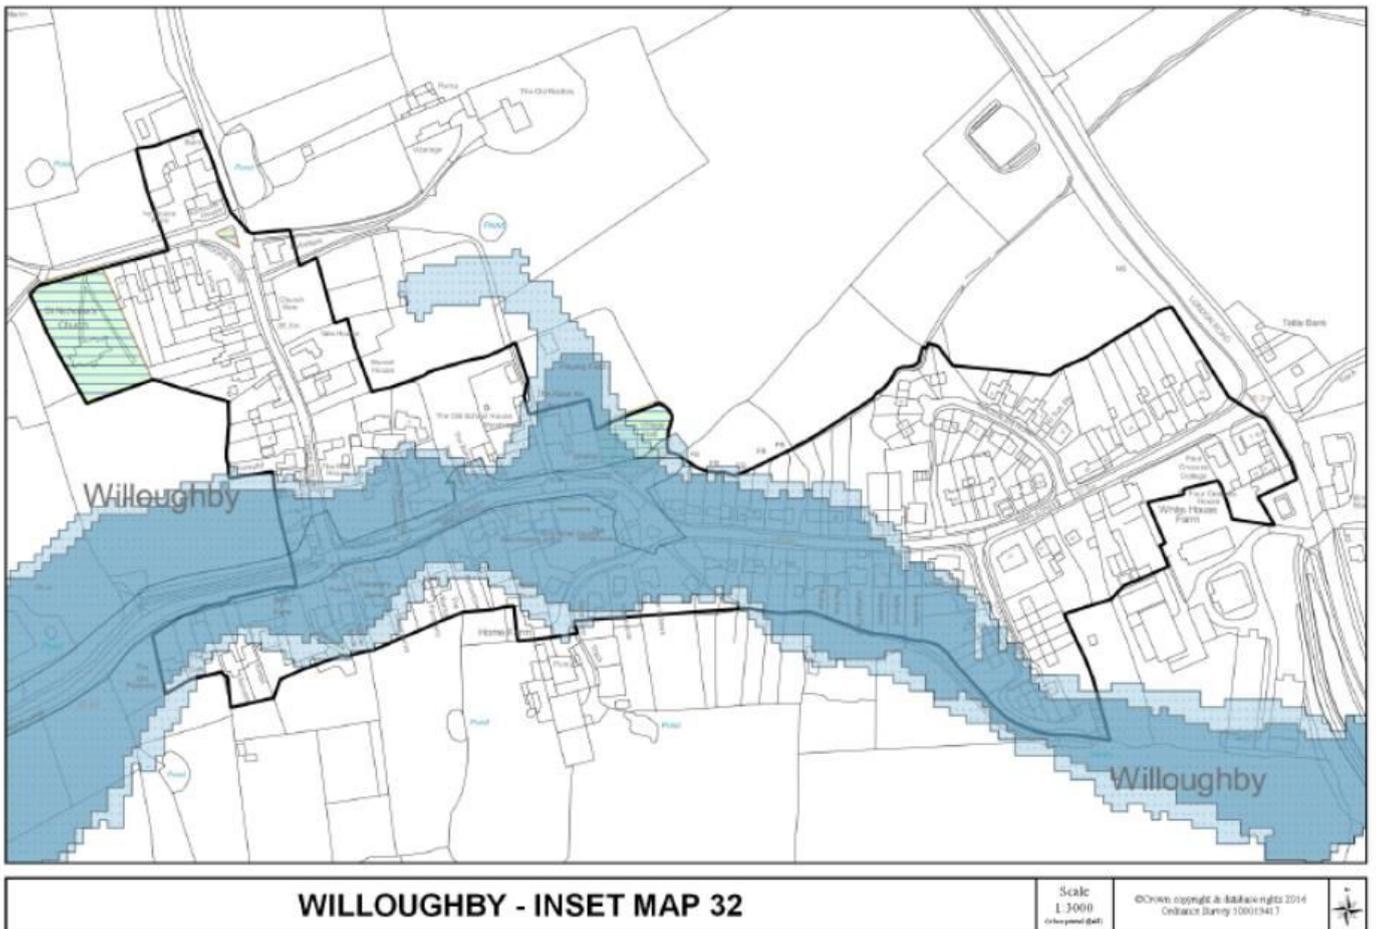
Figure 6. Flood Risk to Properties in Settlement Area - referenced on Page 10. of this report.

Figure 6. of Appendix 6 shows the Category 2 and 3 Flood Zone superimposed upon the Willoughby Settlement Boundaries. (Refer to Appendix 2 for Flood Zone Definitions). Within the settlement boundaries there is very little Cat 2 zone between Cat 1 and Cat 3 zones due to the topography of the catchment. (see Figure 5). It is important to note that the zones are constructed to show maximum accumulation and includes a 20% increase in flow to represent the effect of climate change. Of 150 properties (dwellings) within the settlement 70 are wholly or partially within the Cat 2 and 3 zones. In area this represents approximately 45% of the land area of the settlement.
